Technical Report CERC-95-9
July 1995

Monitoring of the Yaquina Bay Entrance North Jetty at Newport, Oregon; Summary and Results

by Steven A. Hughes, Terri L. Prickett,
Michael W. Tubman, William D. Corson

Final report

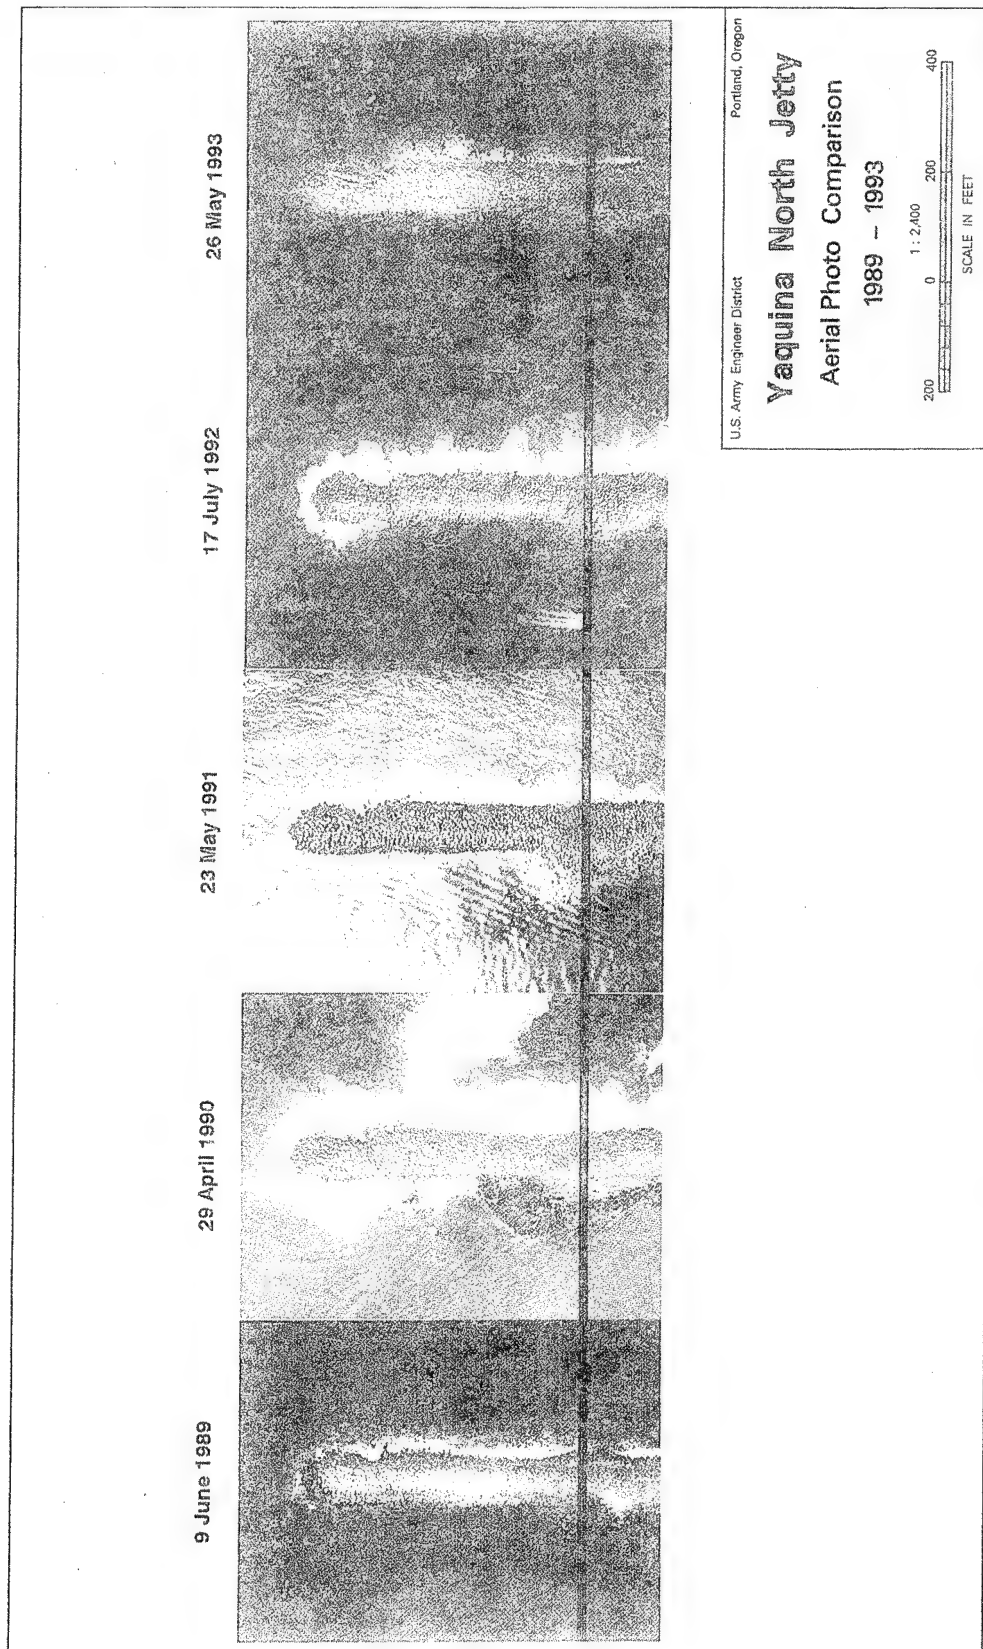
Figure 2. Yaquina Bay north jetty aerial photographs, 1989-1993

Originally, damage that occurred after the north jetty was extended out to the offshore reef in 1966 was thought to have been caused by increased water currents resulting from the proximity of the jetty tip to the reef. It was hypothesized that these currents produced scour at the toe of the structure, thus causing the armor layer to slough off into the scour hole. Under this scenario it was concluded that the remains of the degraded tip of the structure would serve as a stable foundation for the repair performed in 1978. This premise was supported by experience at other jetty structures which had undergone similar rehabilitation. However, the rehabilitated north jetty at Yaquina Bay proved to be unstable, which led to a widening of the possible damage hypotheses to include foundation failure, wave focusing by local

bathymetry, waves larger than the anticipated design waves, and wave/current interactions.

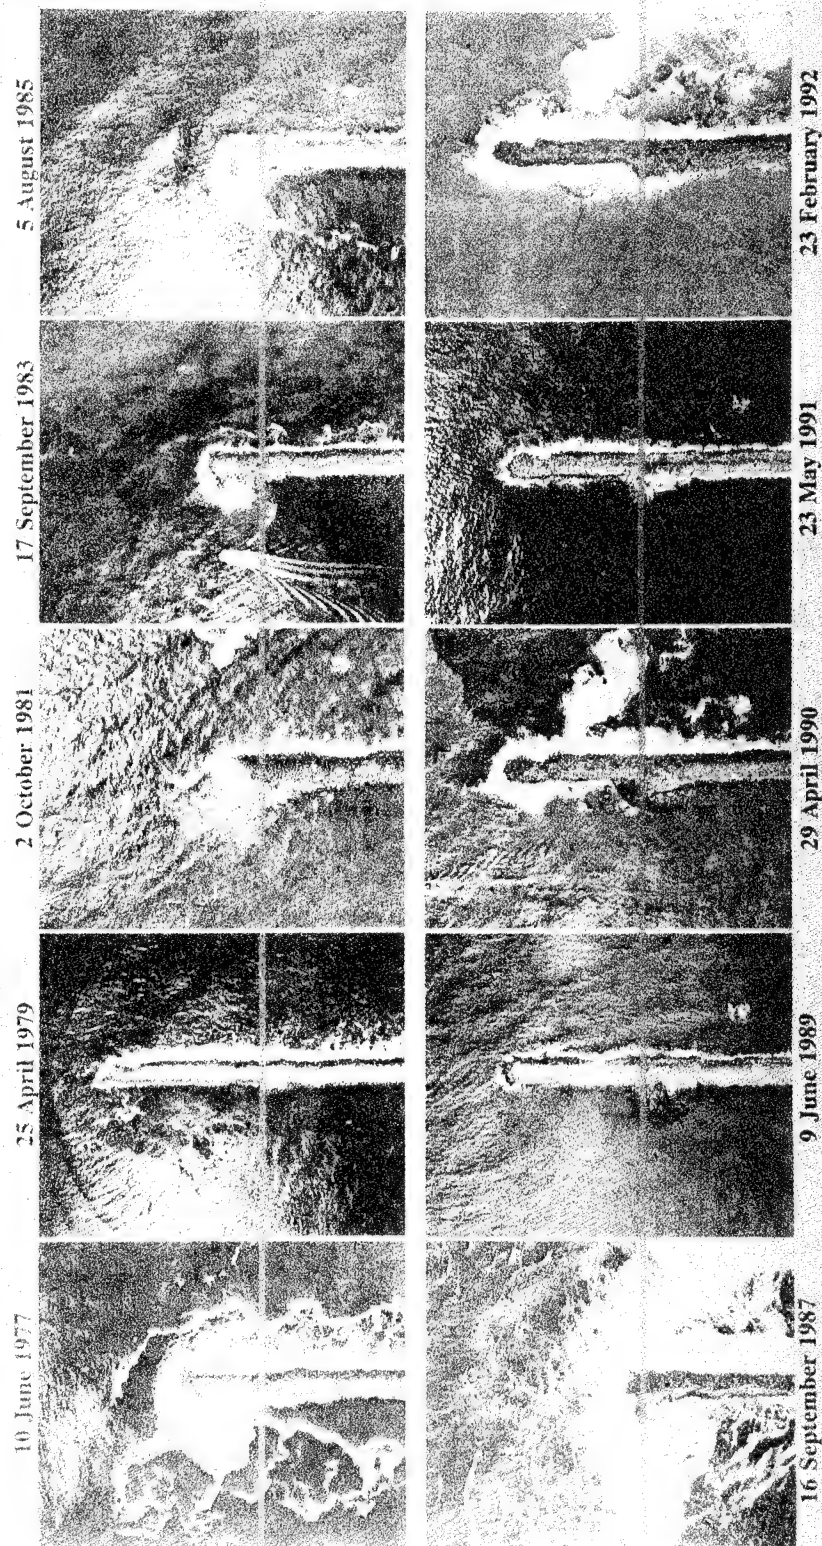
Figure 6. Yaquina Bay north jetty history from aerial photographs, 1977-1992

Almost immediately after completion of the north jetty rehabilitation, damage started to occur on the seaward tip of the structure. Aerial photographs indicated that 12 m (39 ft) of the tip was submerged by April 1979, with subsequent total submerged lengths of 68 m (224 ft) by October 1981, 115 m (379 ft) by September 1983, 124 m (406 ft) by August 1985, and 137 m (450 ft) by September 1987. This sequence of deterioration is shown by the aerial photographs in Figure 6 (the solid horizontal line on the figure is a common line of reference).

Degradation of the north jetty exposed a portion of the navigation channel to increased wave activity, and at times waves would be tripped by the submerged structure, creating difficult wave and current conditions for small craft in the navigation channel. During the winter and spring months, shoals formed on the south side of the channel, forcing boat traffic further northward in the channel (Grace and Dubose 1988). Maintenance dredging for the 10-year period 1978-1987 was estimated to total 2,609,735 m³ (3,413,404 yd³) for an average of 260,974 m³ (341,340 yd³) per year.

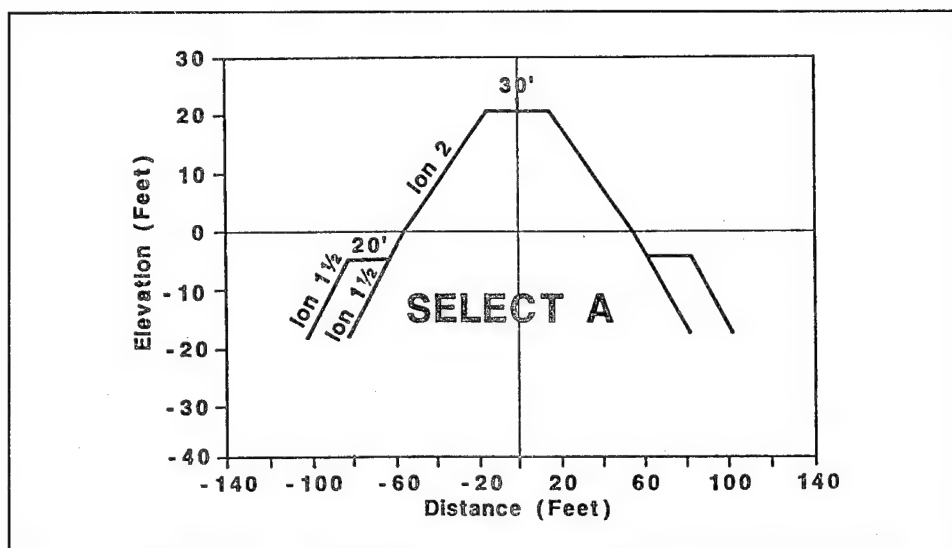
Figure 7. Yaquina Bay north jetty cross section, 1988 rehabilitation

Figure 7 shows the nominal design cross section for rehabilitation of the seawardmost 30 m (100 ft) of the north jetty. The key differences of this design from the 1978 repair were elimination of the class "A" stone core and an increase in the size of the select class "A" armor stone. Thus, the entire end cross section of the jetty was constructed of select class "A" stone having an average weight of 29.5 tonnes (32.5 tons) with a minimum weight specified as 26.9 tonnes (29.7 tons). In addition, a 6-m-wide (20-ft-wide) bench was now included on both sides of the jetty. Behind the select class "A" stone repair section, the next 30-m (100-ft) repair length was armored using class "A" stone with an average weight of 23.4 tonnes (25.8 tons) (minimum 18.7 tonnes (20.6 tons)). The landwardmost portion of the rehabilitation was performed using class "B" stone having an average weight of 16.3 tonnes (18.0 tons) (minimum 12.2 tonnes (13.5 tons)). Details of the 1988 rehabilitation plan are shown on Figure 8. (Note that jetty stations given on Figure 8 do not correspond to jetty stations as labeled for this monitoring study.)

The increase in armor stone sizes over the 1966 extension and 1978 rehabilitation (summarized in Table 1) stems from an increase in design wave height from about 6.6 m and 6.2 m (22 ft to 20 ft), respectively, to 8.5 m (28 ft). This wave height increase was based on deep-water wave statistics that became available in WIS Report 16 (Corson et al. 1987). These statistics were propagated into shallow water using numerical wave transformation techniques to account for refraction and shoaling. Probability of occurrence for the design wave conditions was 5 percent in any given year.

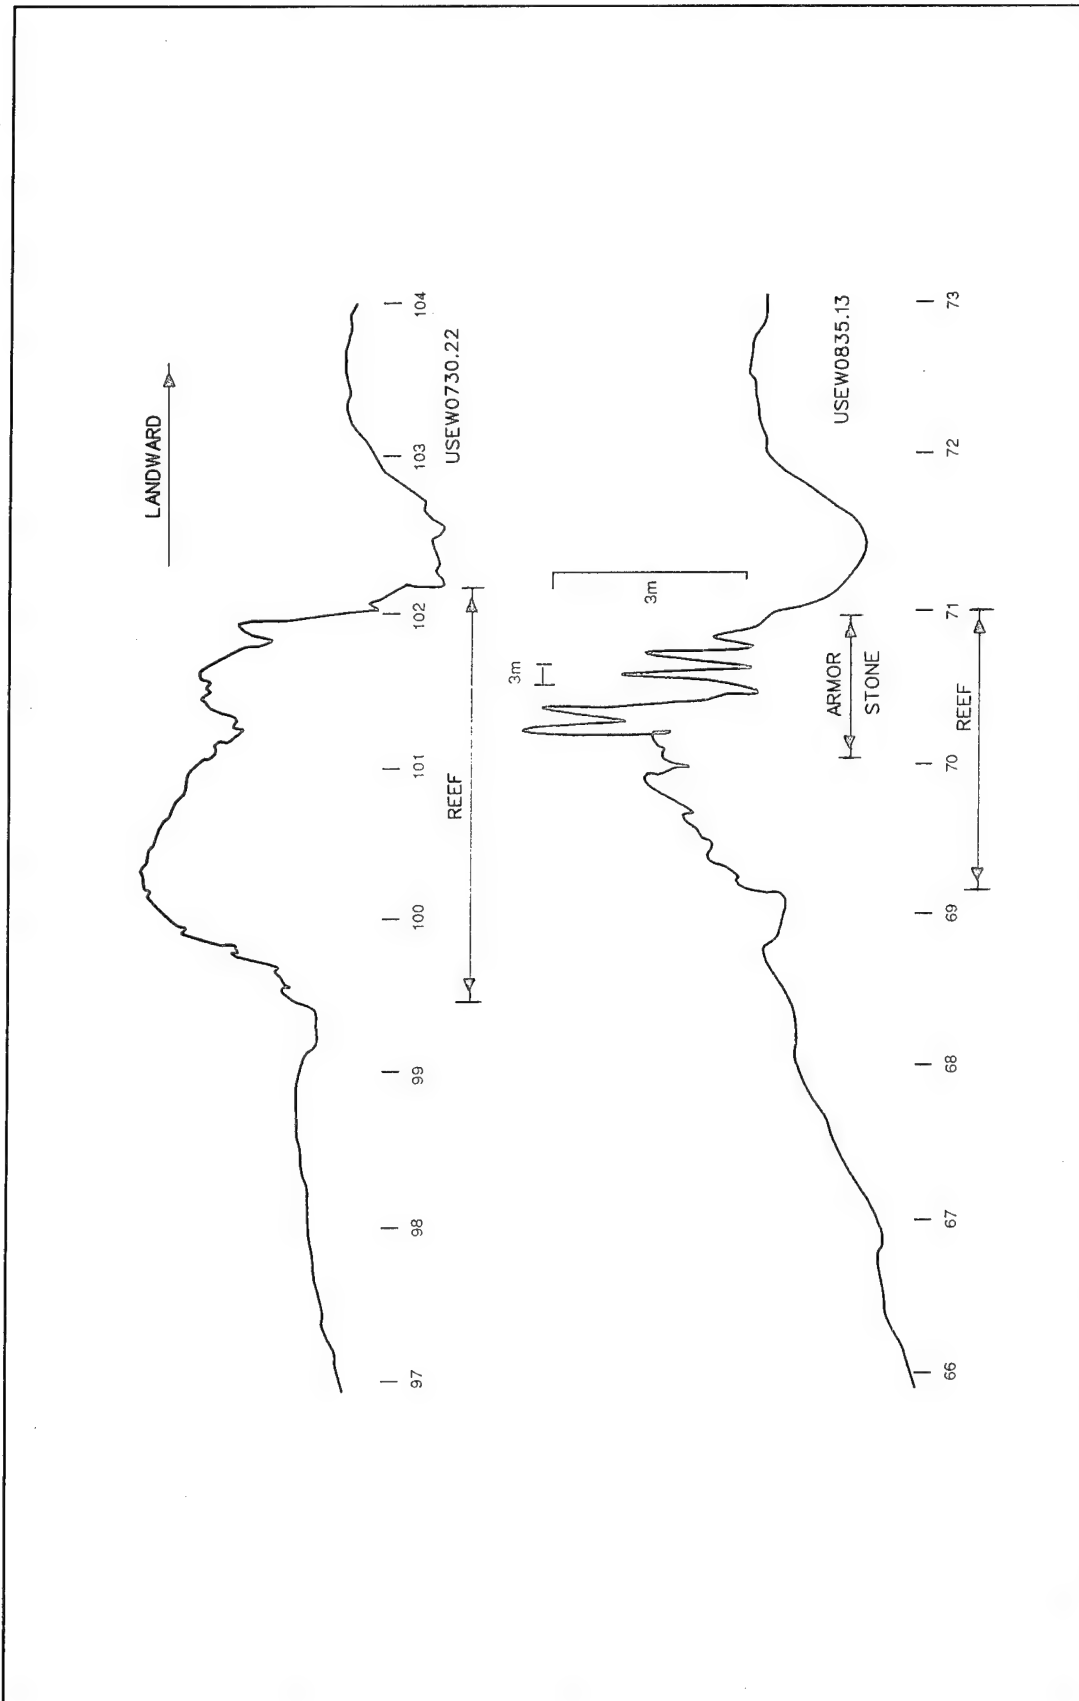
Figure 26. Examples of echo sounder traces transecting the Yaquina Reef

Aided by the side-scan sonar record shown in Figure 27, the bottom echo-sounder trace of Figure 26 was interpreted to be a section of the Yaquina Reef with jetty armor stones resting on the reef, whereas the top trace of Figure 26 shows a section of the Yaquina Reef without jetty stones. The noticeable dip

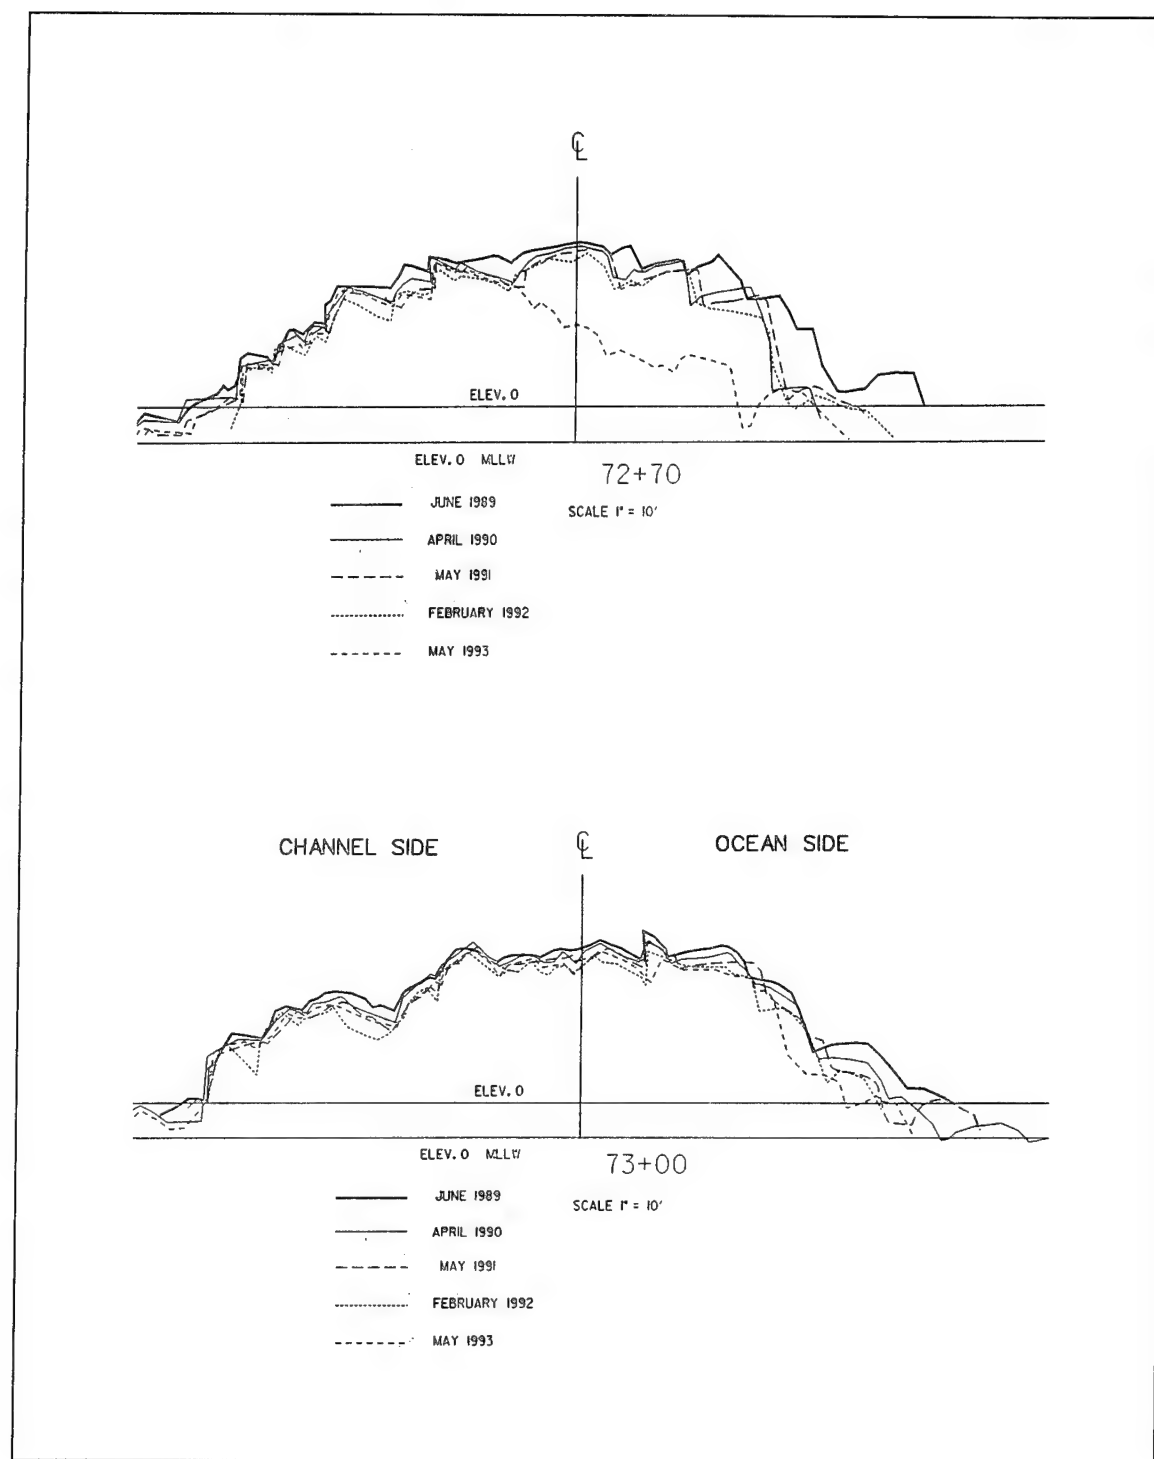
Figure 46. Stereo-model jetty profile comparisons, ranges 72 + 70 and 73 + 00

- c. The most profile change occurred in the vicinity of the "notch" (Figure 45, range 72+40). Significant damage occurred between the years 1989 - 1991. This was followed by a year when the only armor stone losses in the notch area occurred on the landward side of the notch. However, between the 1992 and 1993 overflights, massive profile losses occurred in the notch area to the extent that stones were lost over much of the structure's crest (see range 72+70, Figure 46).

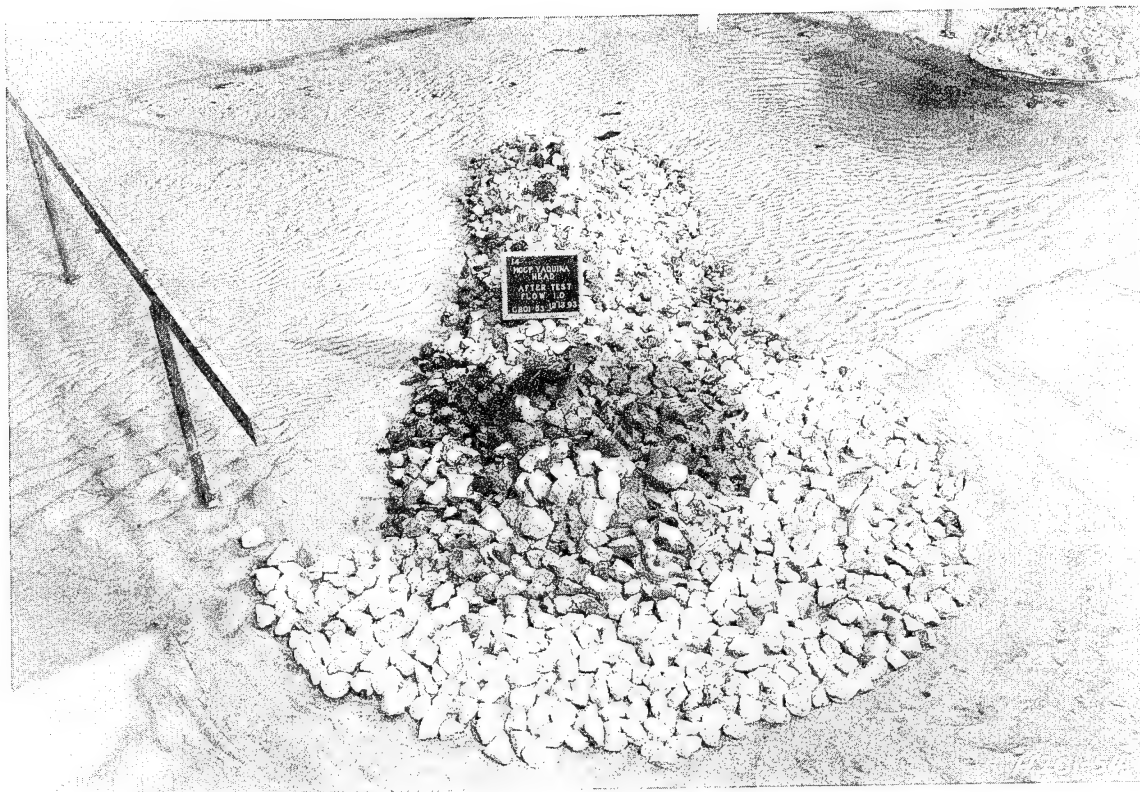
Figure 66. Wave/current stability model showing damage after Test 6

Figure 65 shows the reconstructed Yaquina Bay north jetty head prior to testing. The armor stones in different shaded regions of the structure had been painted so that damage would be easier to spot. Figure 66 shows the condition of the jetty head at the end of Test 6. Although it is difficult to see in the photograph, the armor underlayer had been exposed in an area that
